September, 2018

SOCIAL, ECONOMIC AND ENVIRONMENTAL OUTCOME ANALYSIS OF ABFA-FUNDED PROJECTS: THE CASE OF KEYIME, OHAWU AND DAWA IRRIGATION DAM PROJECTS

Authors: Linda Ahunu, Jo Ann Sackey, Theophilus Adoko, and Akachukwu Okafor

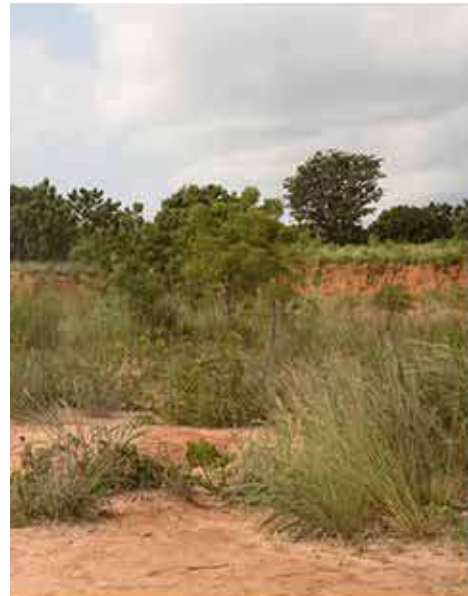
Picture 1: Land degraded by contractor

They are also disgruntled the project contractor who scooped huge quantities of sand from a nearby farm to fill the pathway behind the dam which links Ohawu and the Vume communities. The contractor has failed to reclaim the land from which he scooped the sand, although he was only allowed to do so because he promised to restore the land. Further checks with the contractor indicate that he is still committed to reclaim that portion of land once he is paid to complete the project.

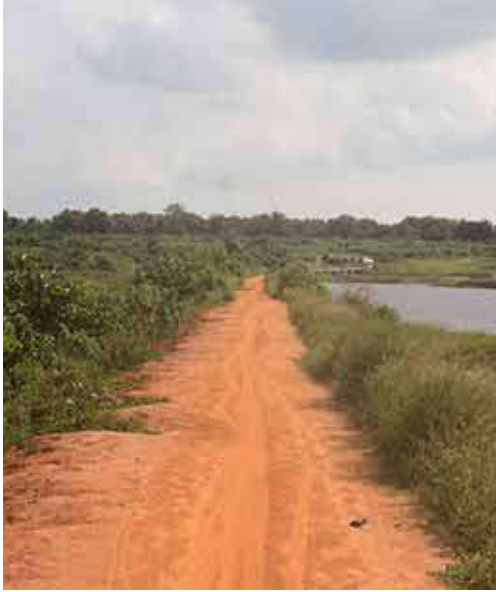
Picture 2: Pathway linking Ohawu and Vume communities from the dam area

Footpaths continue to be flooded with water from the leaking dam, restricting movements. School children have had to use a longer route to school as the shorter route has become inaccessible due to the flooding.

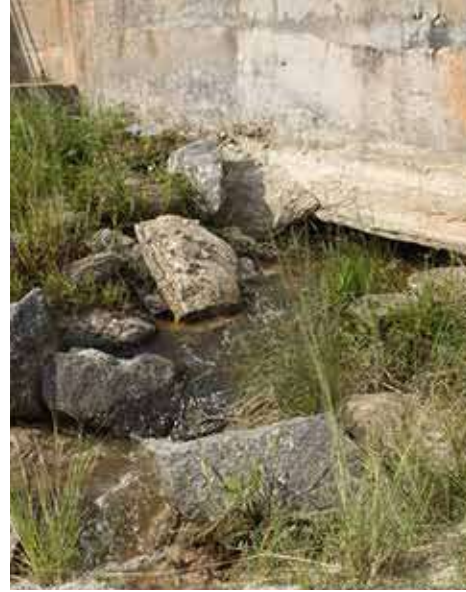
Picture 3: Water seeping from crack in the dam wall

1. As seepage through the dam wall continues, flooding and erosion is inevitable. The community's safety is at risk because if not repaired anytime soon, the dam could collapse eventually.

1. The government must commit funds to complete the Ohawu dam project. This must be done in a timely manner with periodic follow-up by GIDA and the Ministry of Finance to ensure that the project is completed effectively.

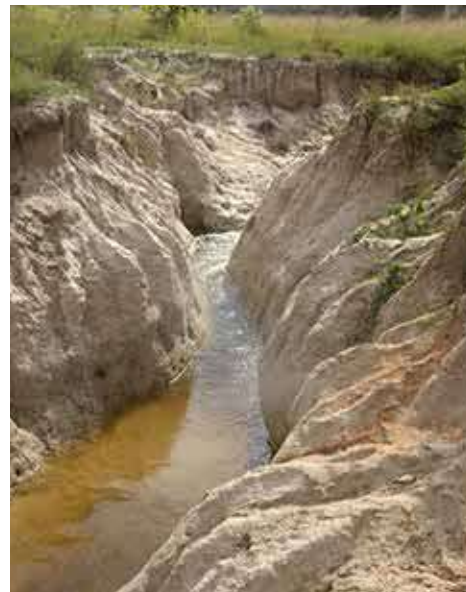
Picture 4: Seeping water creating gullies as it flows from the leaking dam wall

A disaster is waiting to happen as the seepages and other structural defects in the project are already causing erosion that keeps compromising the integrity of the dam. Already, the seeping water has created gullies which threatens safety of community members. Some of the erosion has been contained through communal labour and help from the District Assembly. Further work is required on the site as soon as possible to ensure that the situation does not get worse.

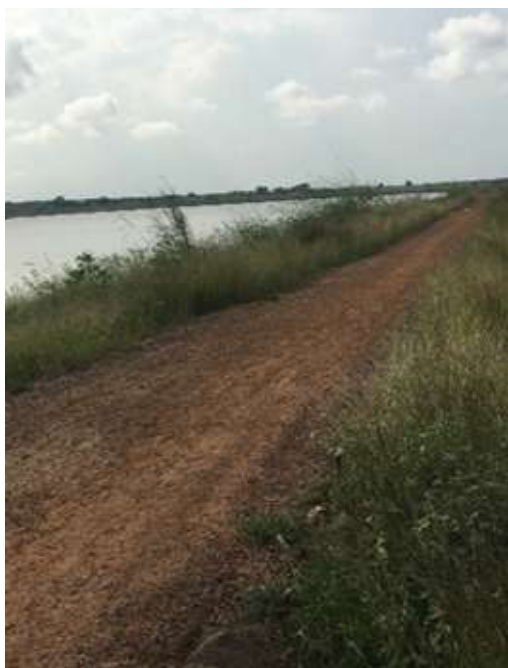
Picture 5: Dawa Irrigation dam wall

In 2015, when ACEP visited the dam to carry out the value for money analysis, the rehabilitation works were complete and the dam was functional. This section explores the economic, social and environmental outcomes of the Dawa Irrigation Project. Below are pictures of the dam.

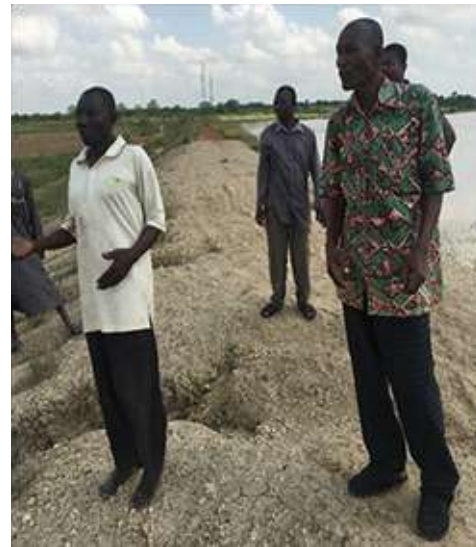
Picture 8: The portion of the dam that was rehabilitated and already suffering from gulley erosion

3. Three years after the rehabilitation, erosion has left the sides of the dam with deep gullies and visible breakaways of soil where the water meets the dam. There is a genuine fear that the dam will be breached once there are heavy rains. This poses as a safety risk to farmers and community members who use the dam as a walk way to their farms and the community on the opposite side of the river.

It is important to note that since the completion of the installation of the irrigation system and the rehabilitation of the breached wall there have been no professional maintenance works carried out on the irrigation system.

4. Erosion of the upstream portion of the dam must be catered for using boulders, gravel or concrete in the shortest possible time to prevent another breach of the dam.

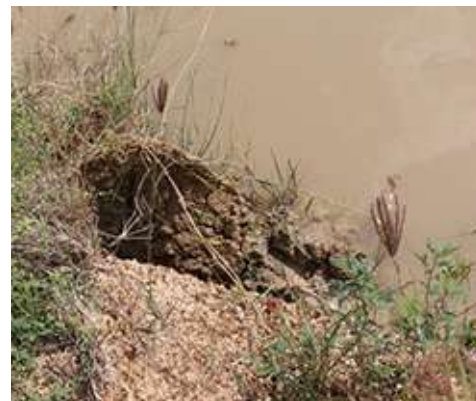
Picture 9: A section of the upstream wall of the dam breaking off

It is insightful that GIDA acknowledges these fears and stressed that its initial plan to incorporate boulders to protect the upstream of the dam against waves of water was shelved due to funding constraints. It however plans to revisit that initial intent when there is funding.

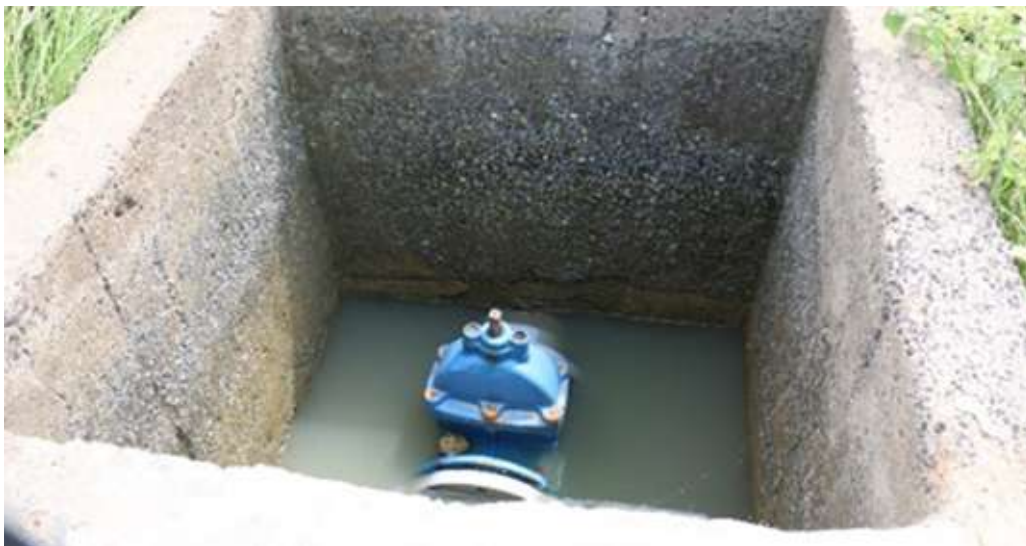
Picture 11: Irrigation pump valve without the handle

There has been misuse of the irrigation system by some farmers forcing the dam committee to detach the valve that turns on the system. The valve is only attached when farmers formally request for the use of the system.

3. Security must be provided at the site of the dam to prevent misuse.
